**PHASE I INITIAL SITE INVESTIGATION**

**93-123 Williams Street  
North Dighton, Massachusetts  
RTN: 4-16565**

**Project Number: R035B**

**September 2002**

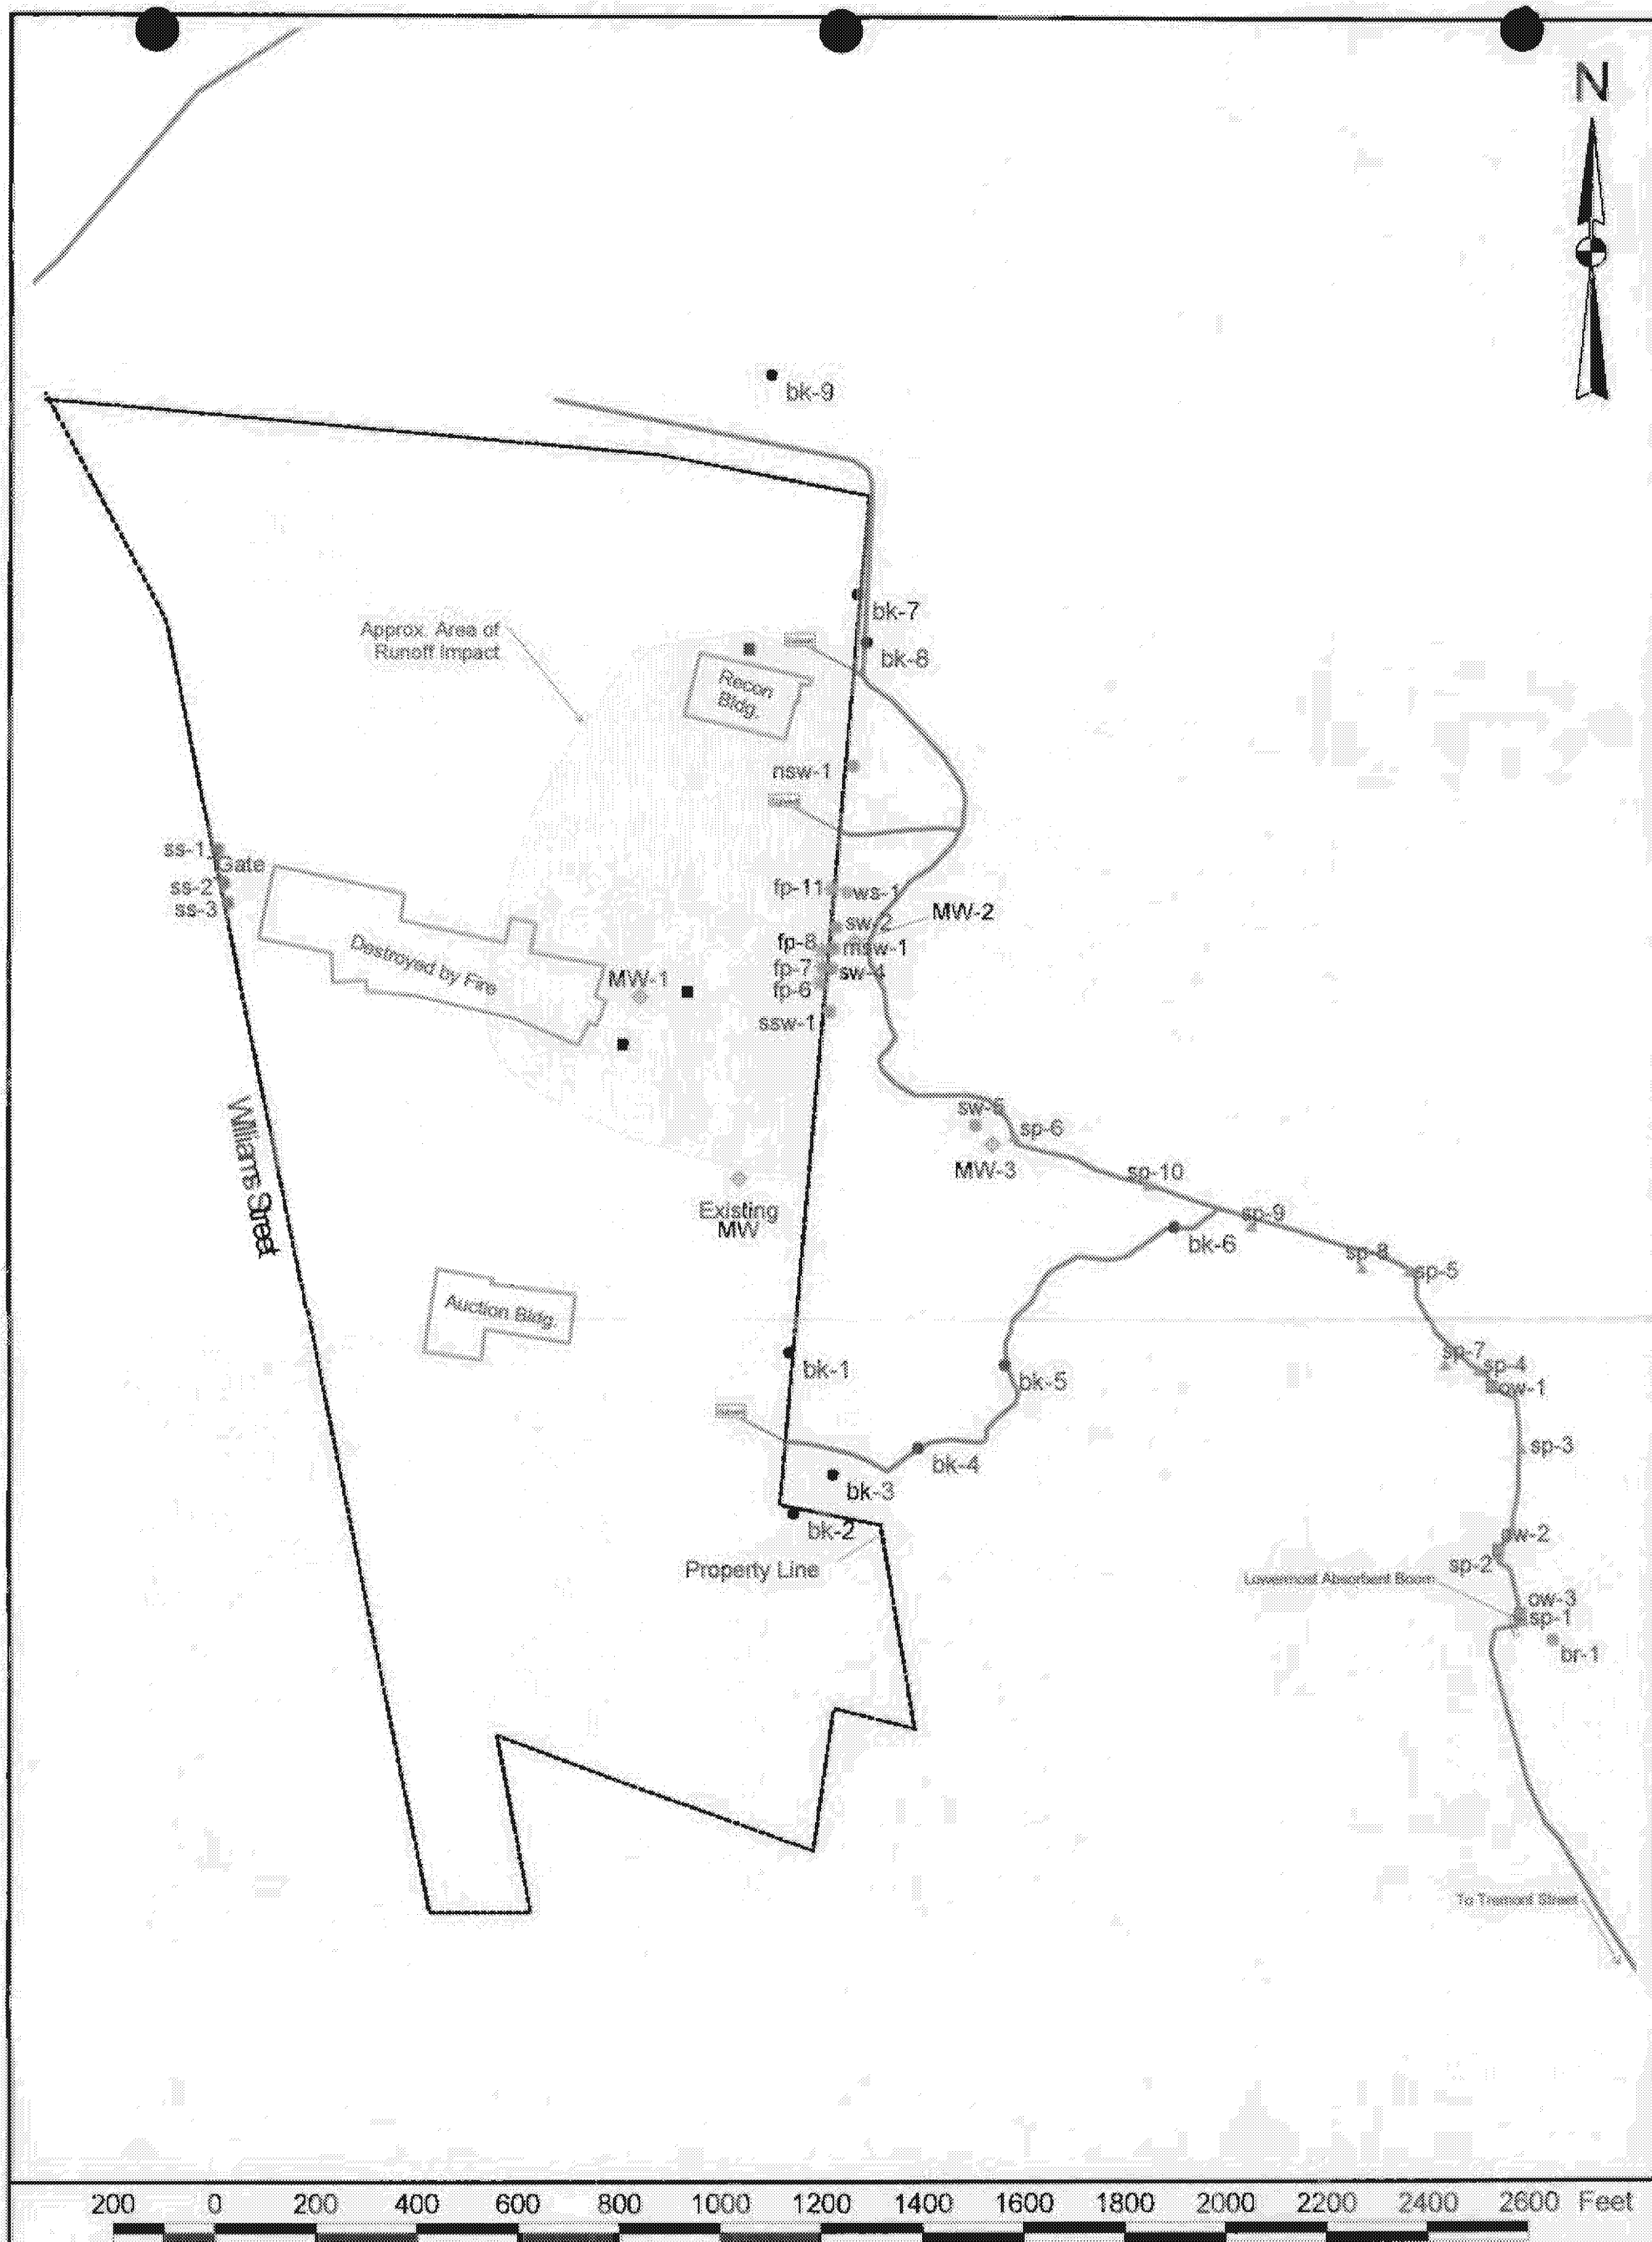
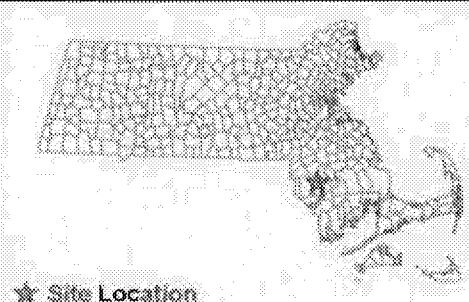
FIGURE 3

**SITE PLAN**  
 American Auto Auction  
 123 Williams Street  
 North Dighton, Massachusetts

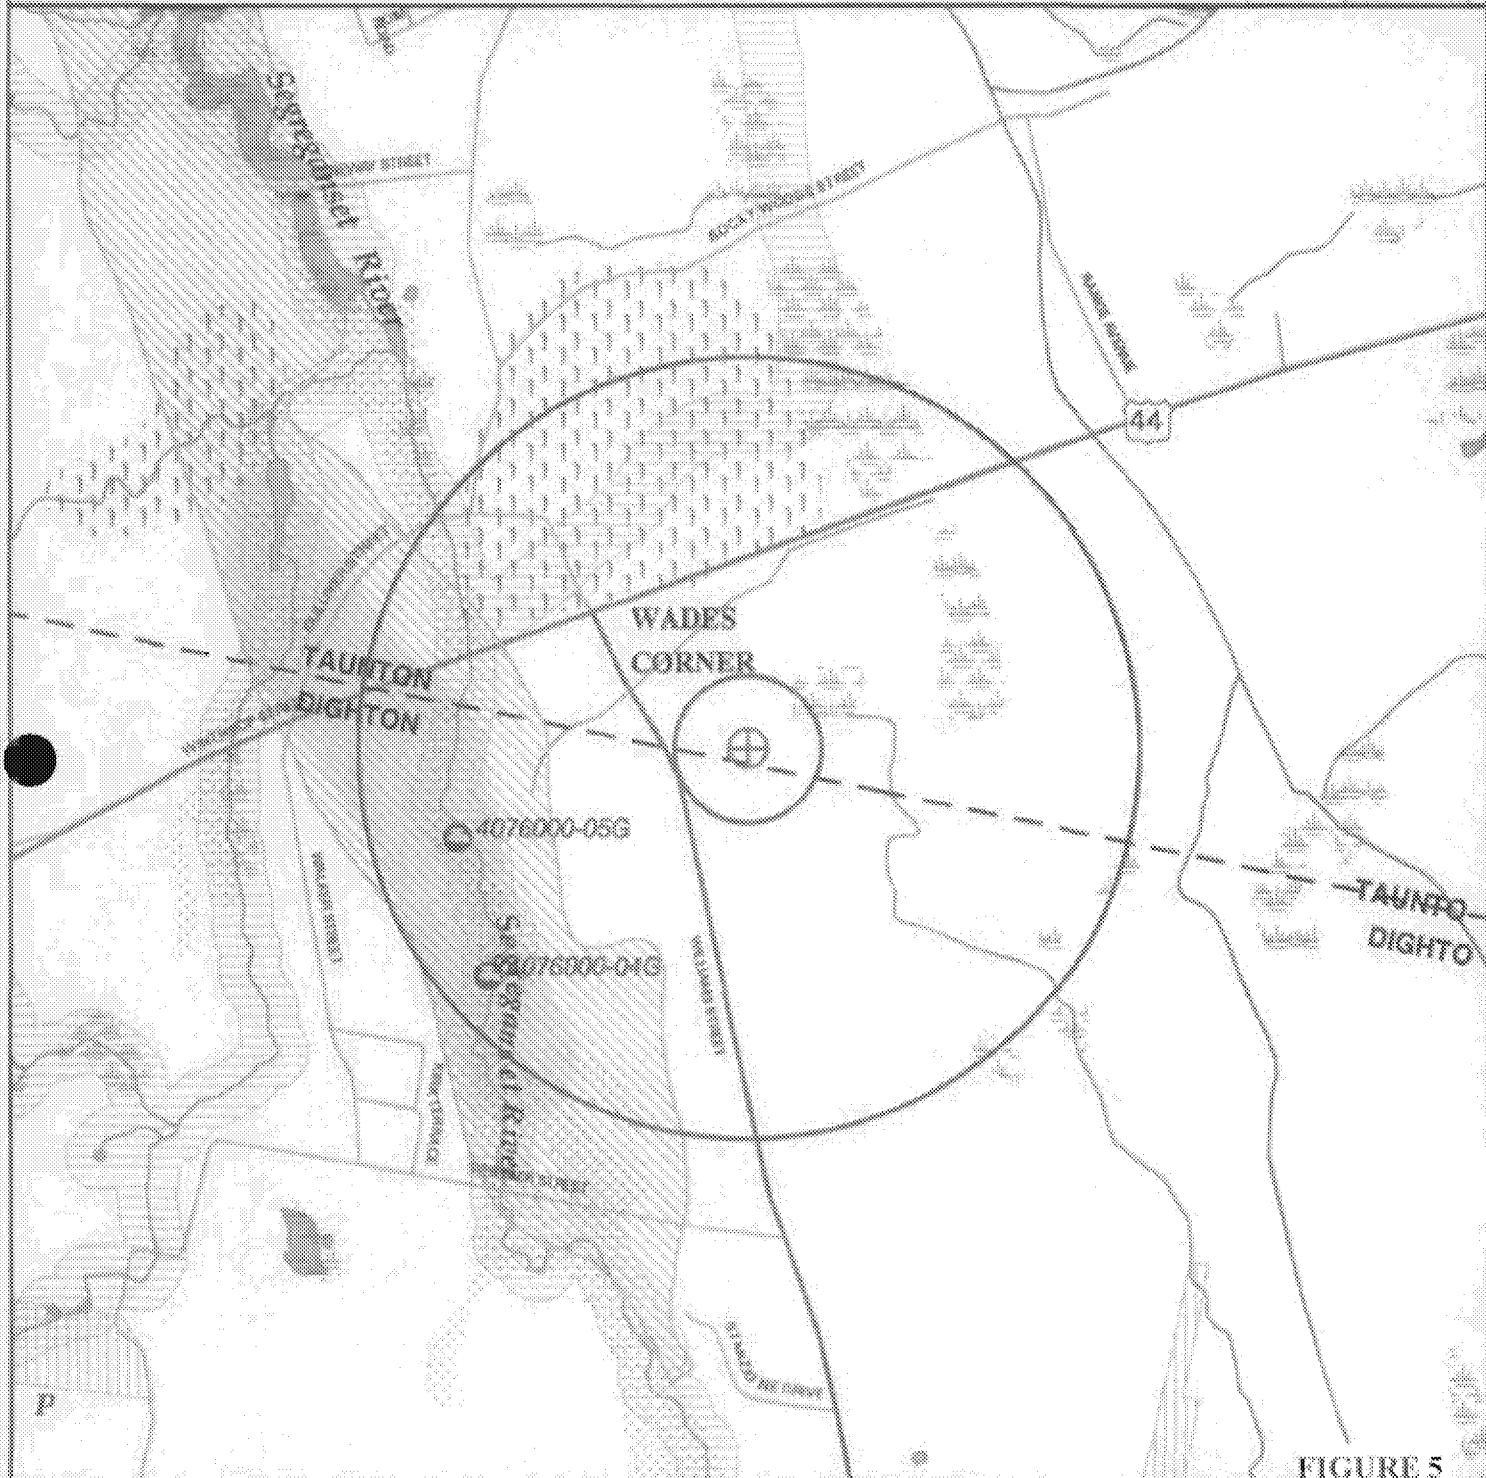
FIGURE 5

Based on a review of the Massachusetts Geographic Information System (MassGIS) Site Scoring Map, the Site is not located within a current or potential drinking water source area. The Site contains an intermittent stream and bordering vegetated wetlands. The stream was observed by *SAGE* to contain a small population of fish including red pickerel (*Esox americanus*). The stream is not located within the Zone A of a Class A surface water body, however, this stream discharges to a Zone A surface water supply located on the Segreganset River 4,000 feet downstream. A copy of the MassGIS Map is included as **Figure 5**.

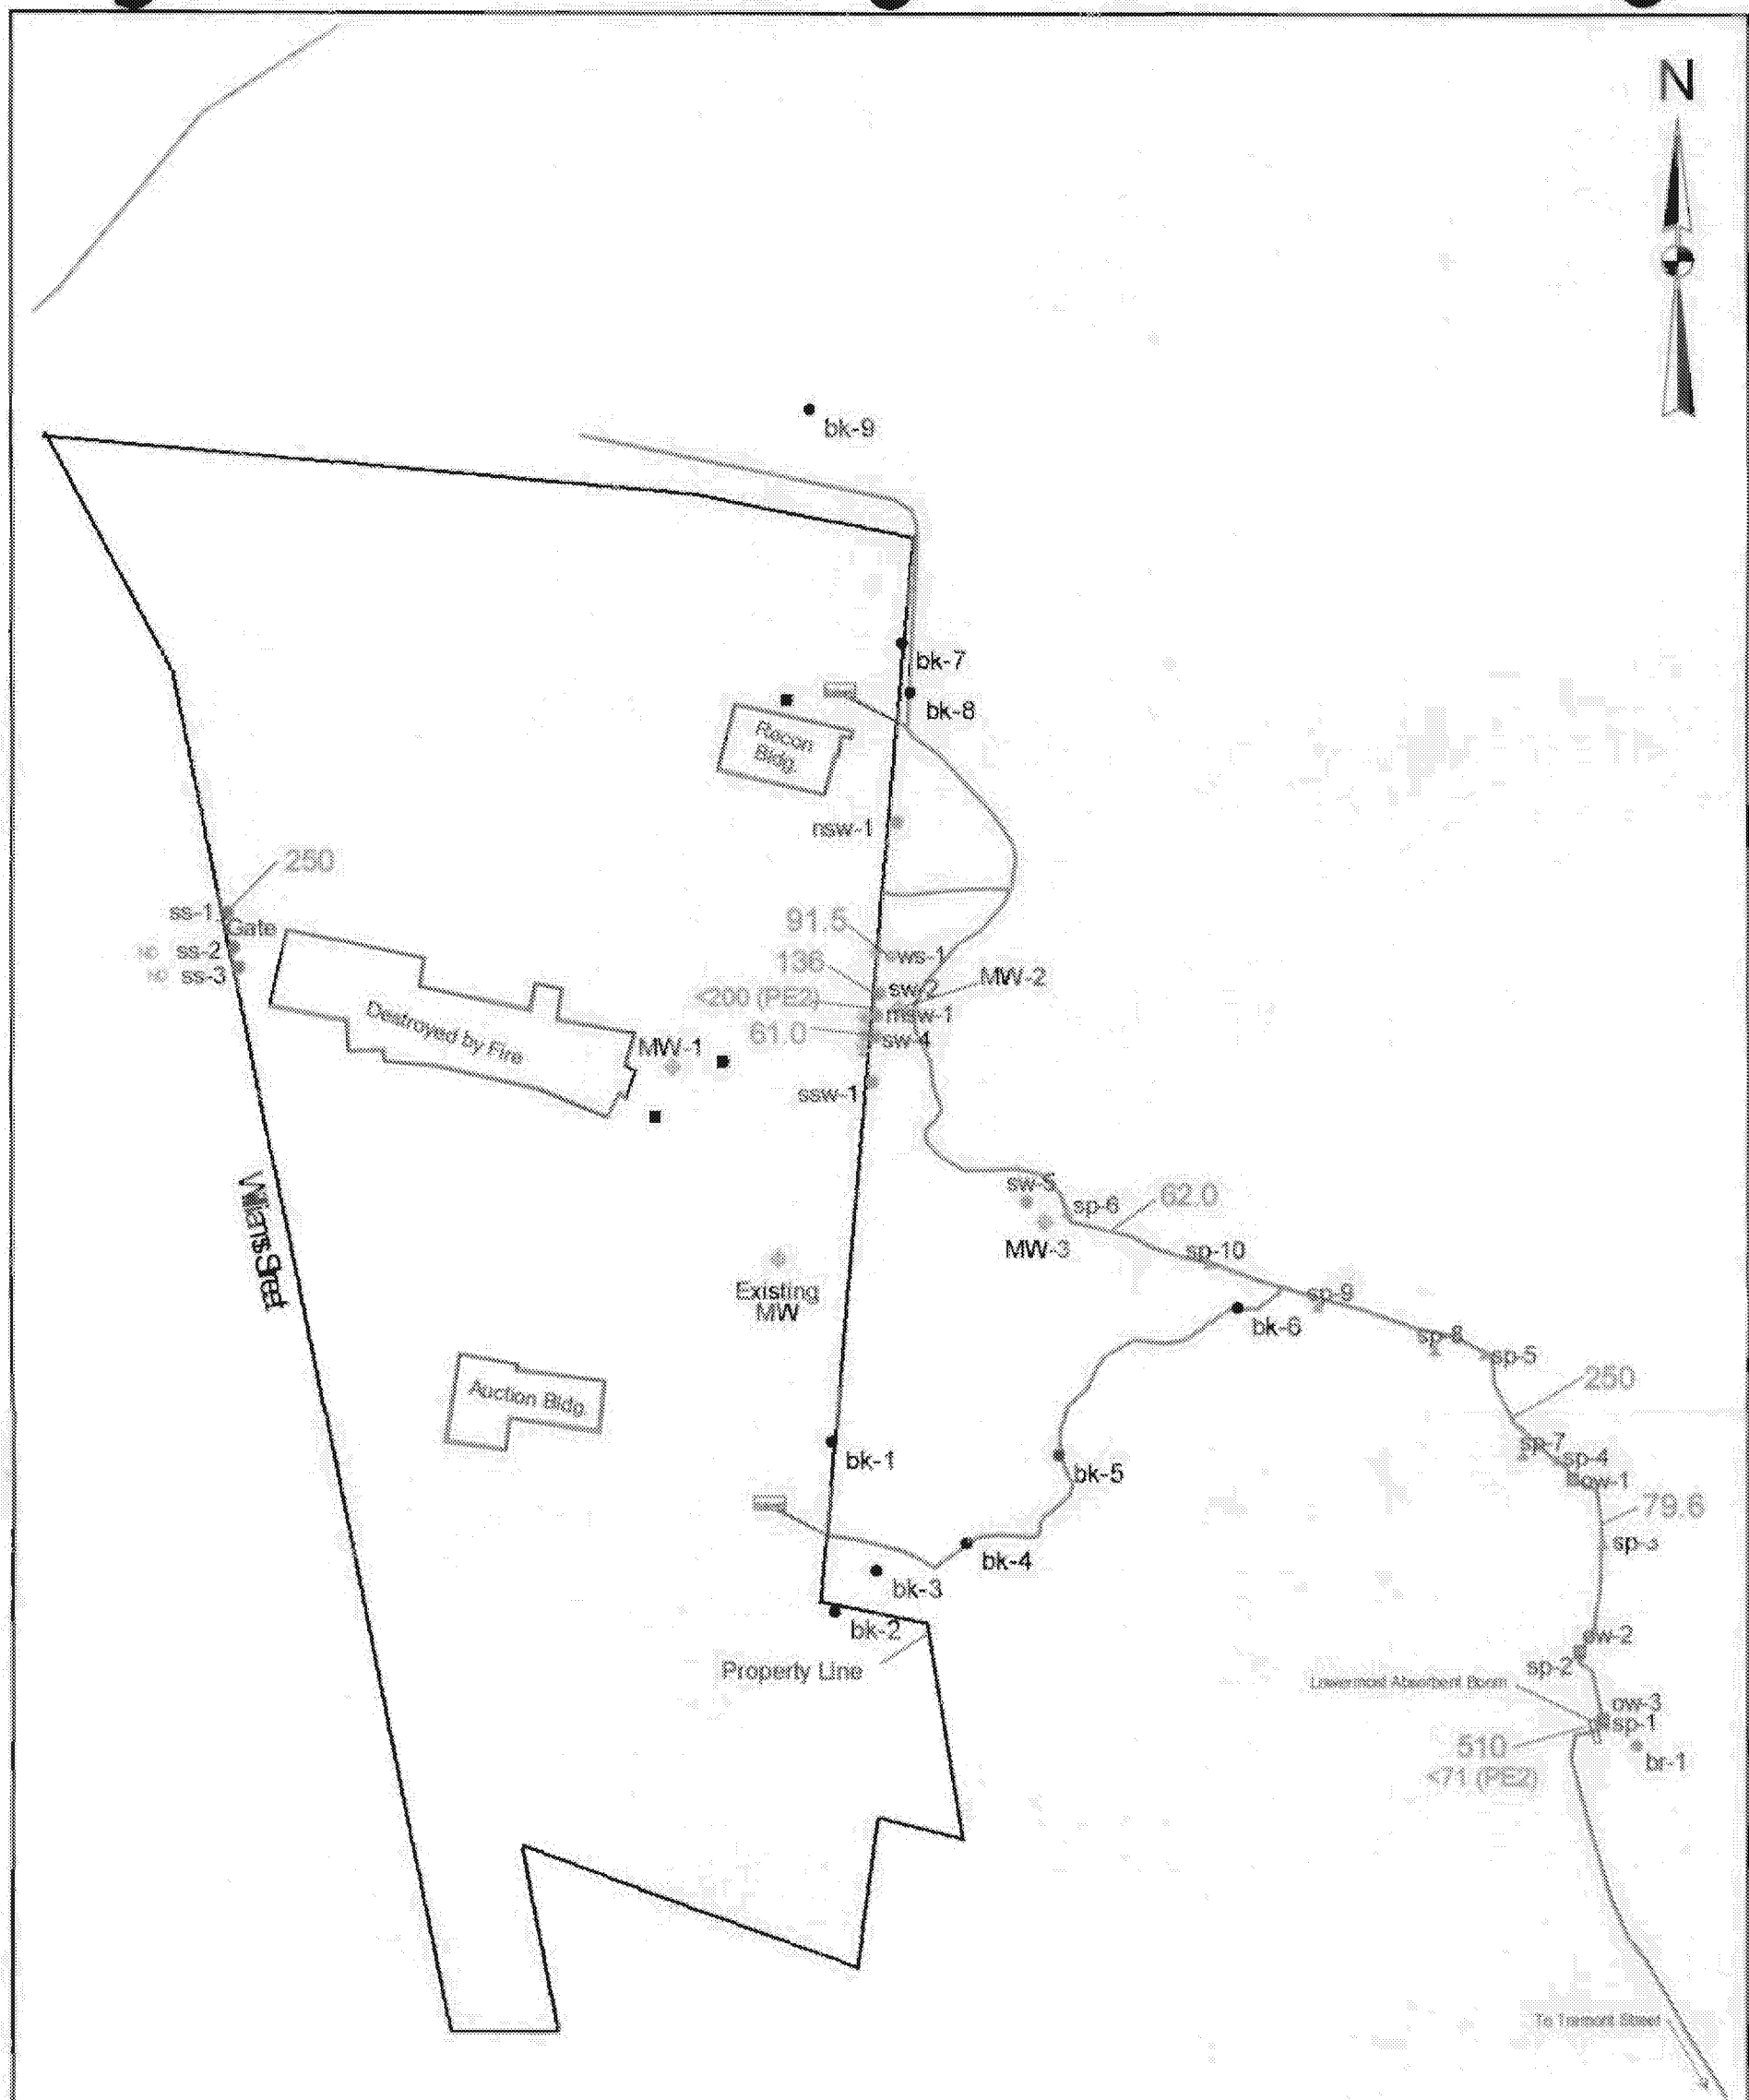
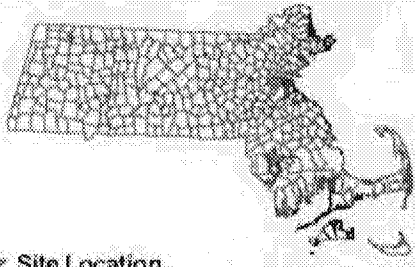
<p>★ Site Location</p>	<p style="text-align: center; font-weight: bold; font-size: 1.2em;">POST-EXCAVATION SEDIMENT AND SOIL SAMPLES PCB'S(ug/kg)</p> <p style="text-align: center;">American Auto Auction 123 Williams Street North Dighton, Massachusetts</p> <table border="1" style="width: 100%; border-collapse: collapse; margin-top: 10px;"> <tr> <td style="width: 50%; padding: 2px;">DATE: 08/16/02</td> <td style="width: 50%; padding: 2px;">SAGE JOB #: R035B</td> </tr> <tr> <td style="padding: 2px;">CREATED BY: RWL</td> <td></td> </tr> </table>		DATE: 08/16/02	SAGE JOB #: R035B	CREATED BY: RWL	
DATE: 08/16/02	SAGE JOB #: R035B						
CREATED BY: RWL

Seven (7) of eighty post-excavation sediment samples had detected concentrations of PCBs. All detected PCB concentrations are significantly below the IRA objective of 1000 ug/kg. The highest level of residual PCBs was noted in the streambed of the

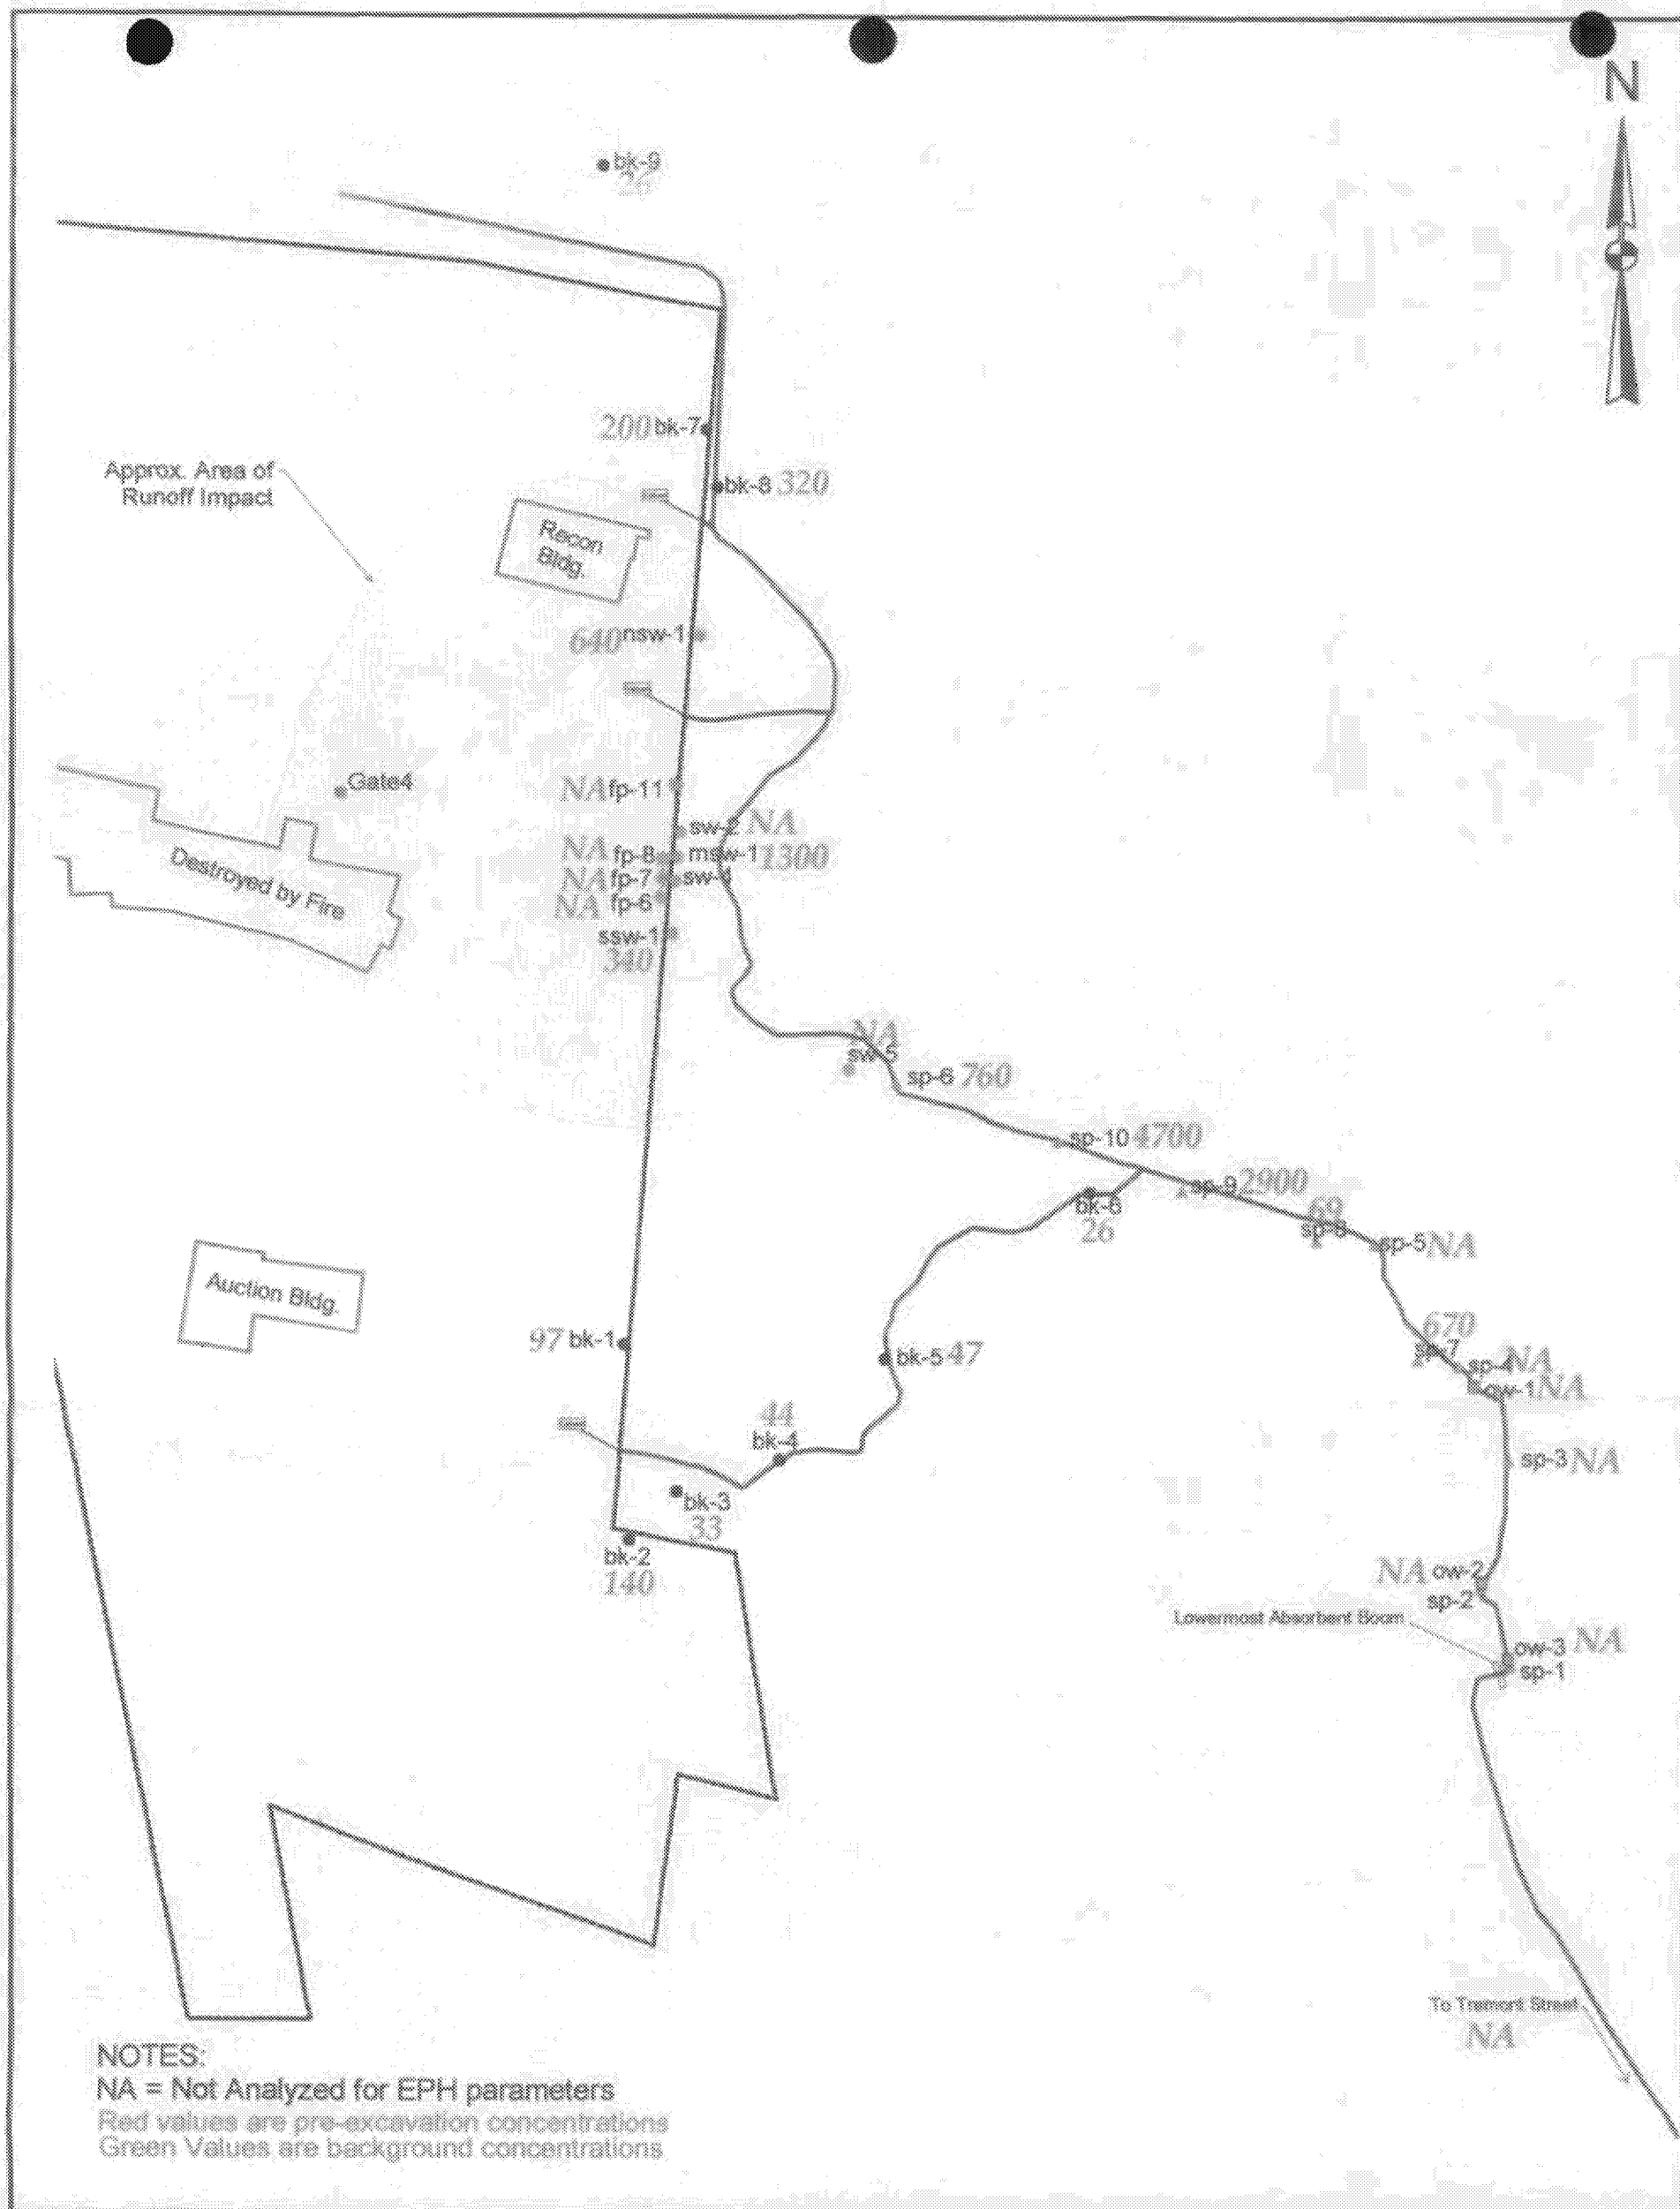
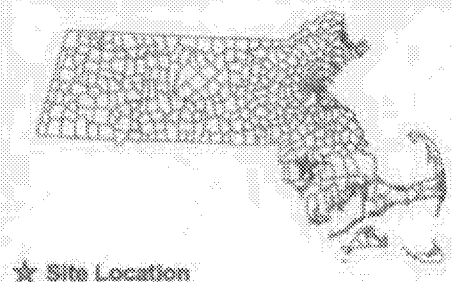
FIGURE 8

Pre-excitation Sediment/Soil Samples  
 C11-C22 Aromatics (mg/kg)  
 American Auto Auction  
 123 Williams Street  
 North Dighton, Massachusetts

With consideration to the above data, PCB impact to sediment appeared to be greatest in the downstream areas of the constructed drainage channel. Both Arochlor 1254 and Arochlor 1242 isomers were observed in laboratory findings. EPH concentrations in the streambed sediments were in excess of MADEP Method 1 soil standards, with C11-C22 aromatics being the most persistent and elevated fraction. EPH concentrations in background sediment samples are also elevated, suggesting that EPHs in the streambed sediments may be more the result of historic parking lot runoff rather than the subject transformer release.

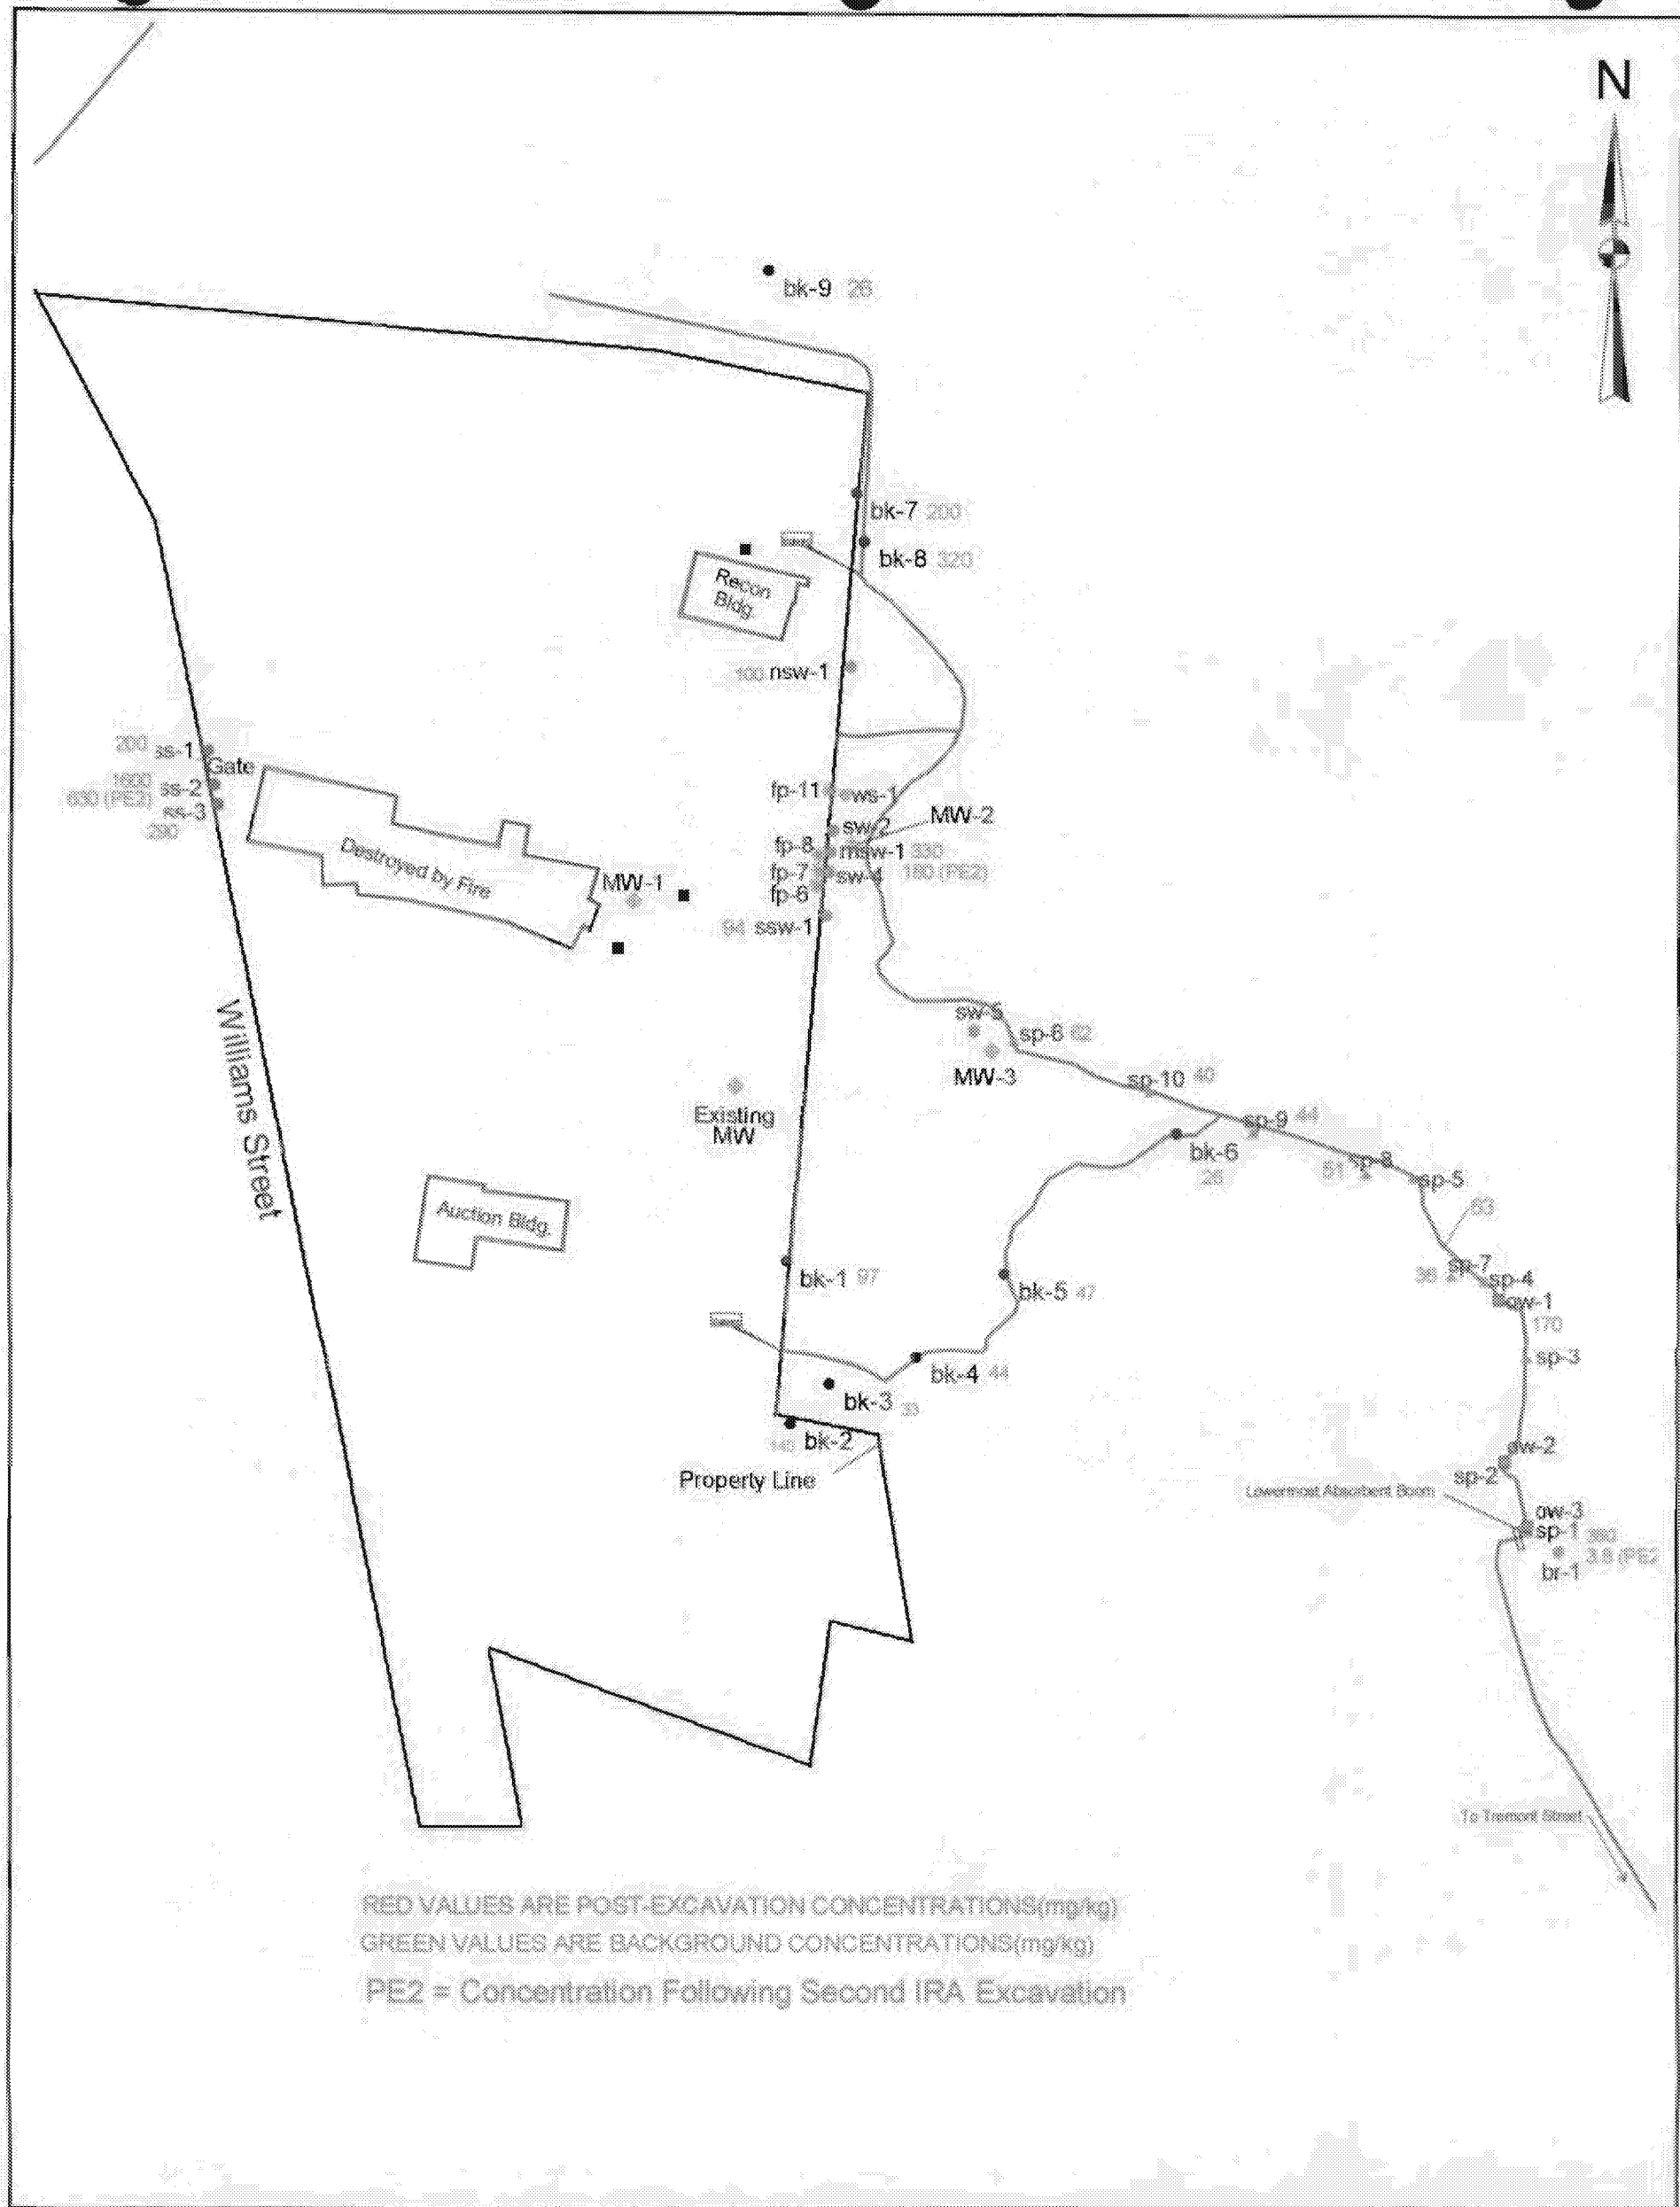
Chain-of-Custody forms and Certificates of Analysis are included in **Appendix 7**. Post excavation PCB data is summarized on **Figure 7**. Post excavation EPH data for the C11-C22 aromatic fraction is summarized on **Figure 9**. Laboratory results are summarized on the following **Tables 6, 7, and 8**.

NA: Analysis not performed  
ND: No analytes detected above quantitation limits  
<x: Indicates analyte concentration not detected at or above specified laboratory quantitation limit (x)  
Sample Results:  
a-c: Analyte concentration in this sample exceeds the MADEP standard for:  
a: S1/GW1 type soil  
c: S1/GW3 type soil  
Aromatic concentrations are depicted on Figure 9

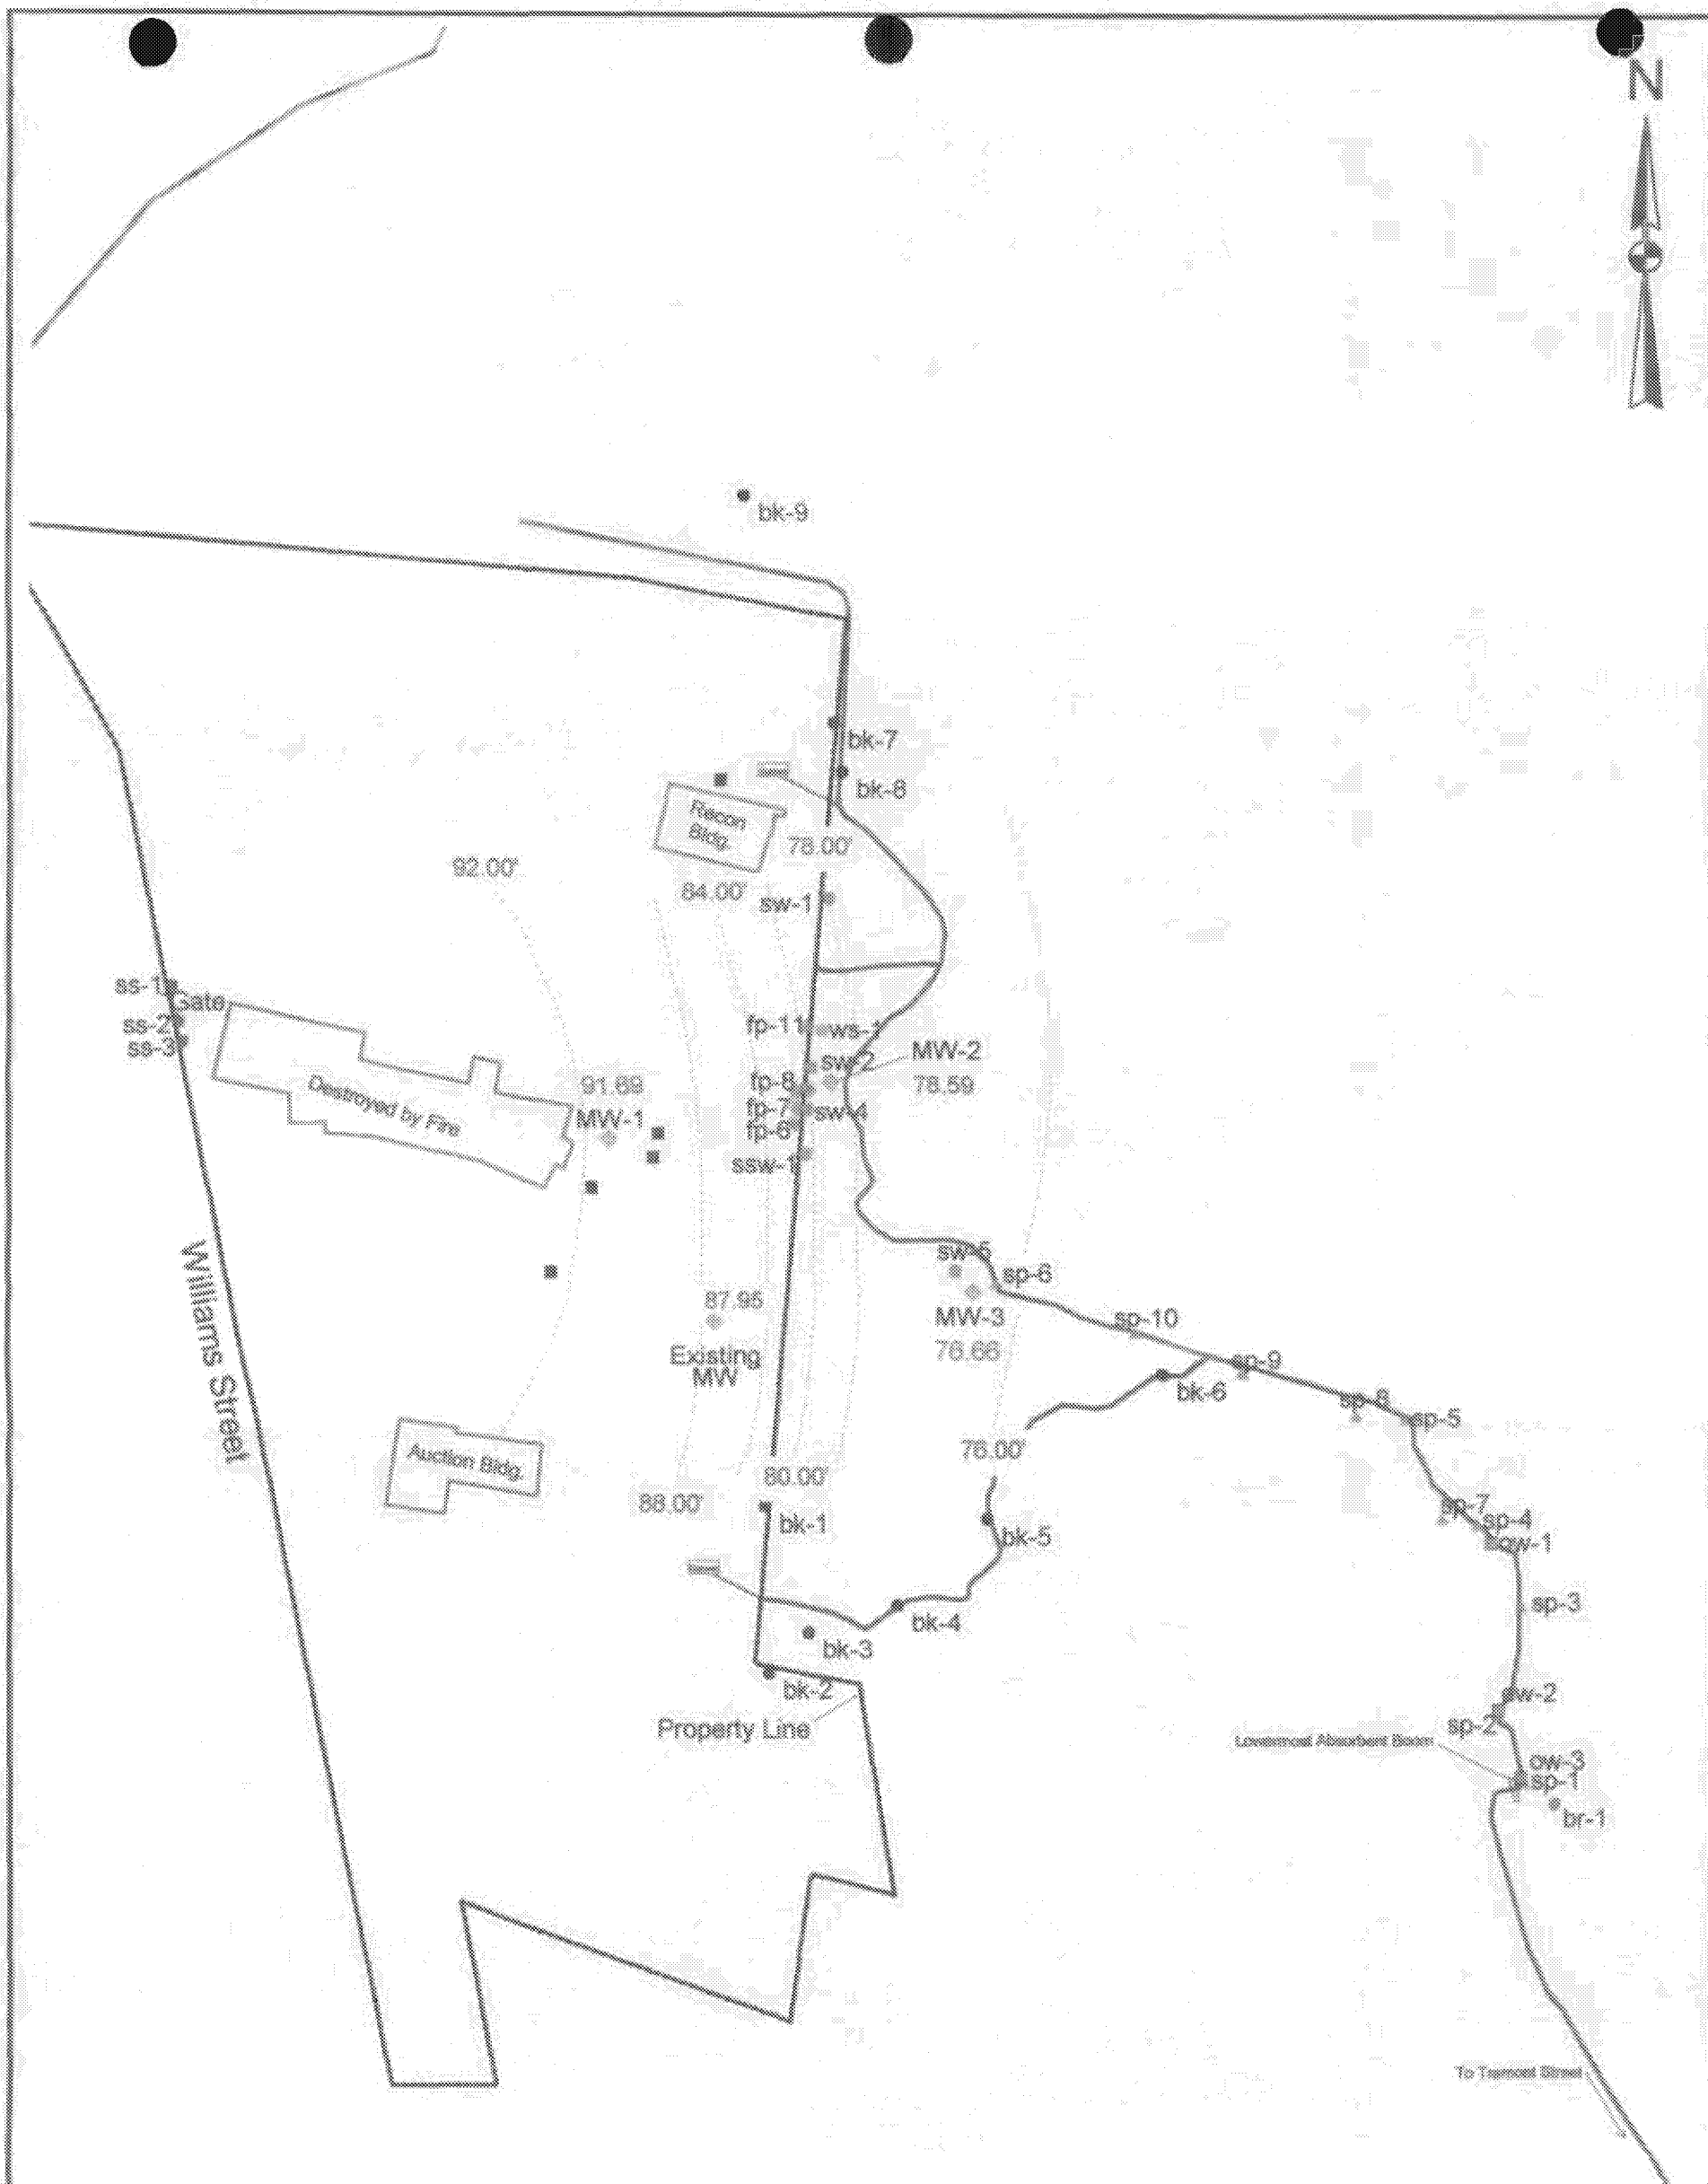
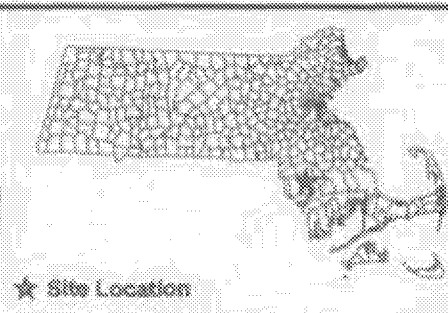
FIGURE 10

The above data was used to construct a groundwater contour map (**Figure 10**) which depicts the apparent groundwater flow direction across the Site. The overall groundwater flow on the site appears to be in an easterly direction toward the wetlands. This groundwater flow direction assumes homogeneous isotropic aquifer conditions and may vary seasonally.

## GROUNDWATER CONTOUR MAP

On April 22, 2002, the elevation of all monitoring wells on the Site was surveyed relative to an arbitrary datum located at the top of the yellow hydrant at the north end of the parking lot (designated as 100.00'). Groundwater levels in all monitor wells were gauged on May 1, 2002 using an interface probe capable of differentiating between light non-aqueous phase liquid (LNAPL) and water. LNAPL was not observed in any of the monitor wells. Well gauging data is presented in **Table 18**.
